OUR REFERENCE : 22159 (MHP Job No.41089)

# MHP Engineering Service Division

IFE INP 400x1500/6 - FABRICATION No.: 41K121050-01/14269

# INSPECTION FINDINGS

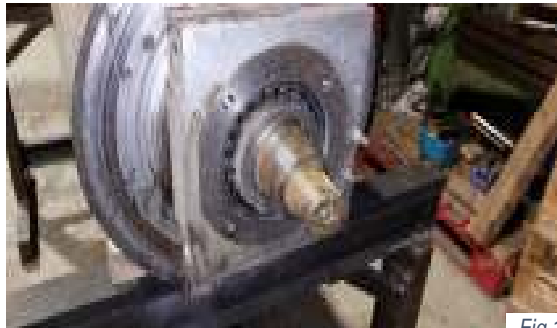
Fig 1

On arrival of the ECS rotor to our works, we firstly proceeded to visually inspect the external condition of the rotor assembly prior to stripping. Observation of the drive end highspeed bearing housing assembly, missing was the housing end cover Flange/Adaptor. We also noticed a lack of grease in the bearing rolling elements that would not be consistent for a rotor in operation for over three years. This would indicate that the incorrect lubricating schedules have been adopted.

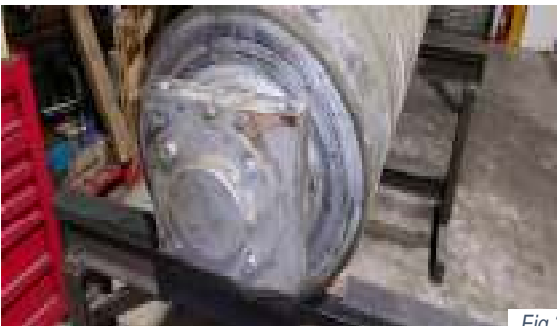
Fig 2

Visual observation of the non-drive side highspeed bearing housing & end cap shows signs of excessive heat presence and slight blistering of the paint work on the housing face. It also shows evidence of grease bleed from the lower position of the housing where the grease has liquidized due to the elevated temperatures experienced during its operation.

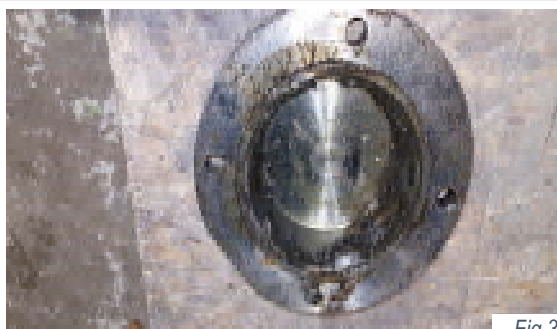
Fig 3

On removal of the non-drive side bearing end cap, we immediately could smell burnt grease & clearly see that the grease present in the end cap has become fluid & blacken from impurities generated from rolling element contaminants. Raised temperatures caused from the rolling element wear debris contaminating the grease over time that has not been purged from the bearing at routine greasing intervals during its operational life will cause this effect.

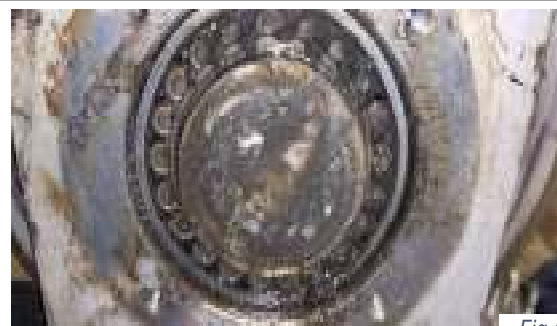
Fig 4

Removal of the Non-Drive High Speed Bearing cover exposed a fluid and heavily contaminated grease choking the rolling elements. This will over time restrict the expelling of rolling element wear debris from the bearing that will elevate the bearing temperature to a level where the grease begins to breakdown. At this temperature level the oil will separate from the other grease constituents (Soap) creating a very wet & fluid consistency. Humidity will also increase in the bearing causing emulsification.

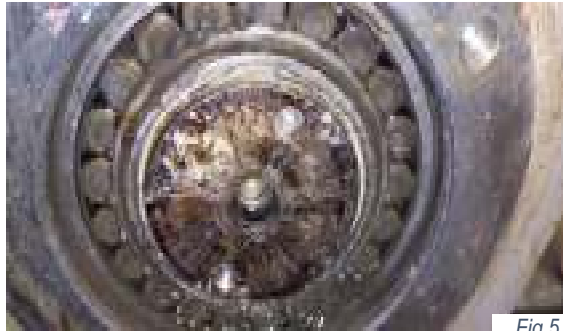
Fig 5

Due to the heat generated by the contamination of the bearing assemblies, the distance end setting plate fixing screws have become sweated into place & have both had to have the countersunk heads drilled to release the distance plate from the shaft end.

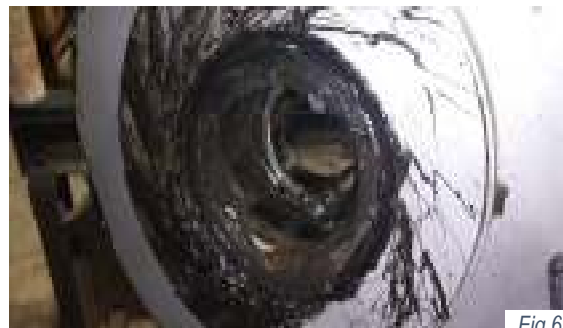
Fig 6

Examination of the Non-Drive side high & slow speed bearing housing assembly clearly shows it is fully choked with wet fluid & heavily contaminated grease which has blown past the internal fitted rotary seals. We have also found several of the spherical rollers have dropped out of their retaining cage due to wear & areas of emulsified grease from elevated temperatures. We also have signs of corrosion to the inward facing bearing surface caused from increased moisture.

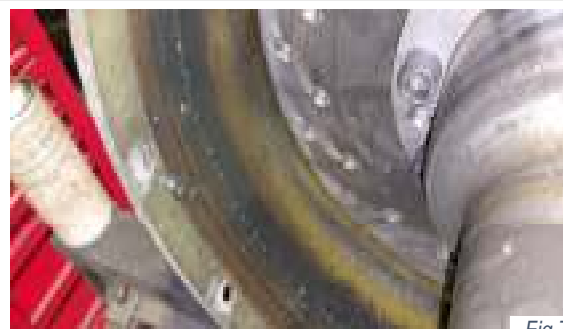
Fig 7

Removal of the Non-Drive side high & slow speed bearing housing assemblies exposed the internal condition of the Rotor cover end & magnet system. It was clearly noticeable that contaminated wet fluid grease & rolling element wear debris has entered the cover after being forced past the rear internal rotary seals & deposited itself around the inner diameter.

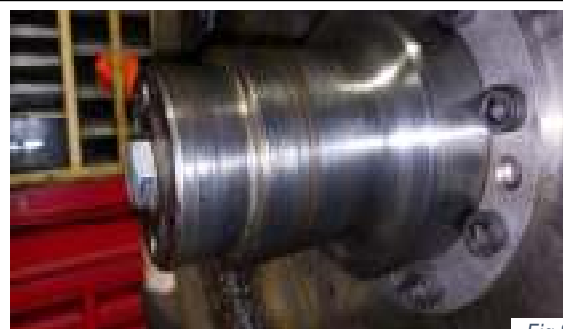
Fig 8

After thoroughly cleaning the bearing & seal journal diameters of the rotor shaft non-Drive end we found that the bearing journal was undersize from bearing movement and the seal journal diameter has worn below the recommended minimum standard from the effect of contaminated grease & debris passing under the sealing lip creating a grinding paste that has left an uneven & under size surface. Elevated temperatures have worsened the effect overtime.

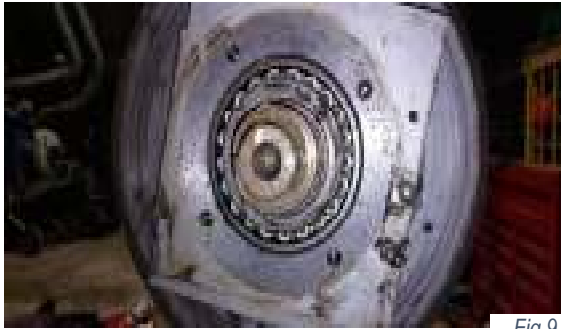
Fig 9

Inspection of the Drive side High Speed Bearing end showed minimal levels of grease present in the spherical bearing rolling elements. This is in-consistent with a bearing being correctly greased over a three-year operational period. Most of the grease lubrication in the bearing assembly has filled the rear of the Highspeed bearing, housing causing the rotary seal lip to lift, allowing for the grease to escape.

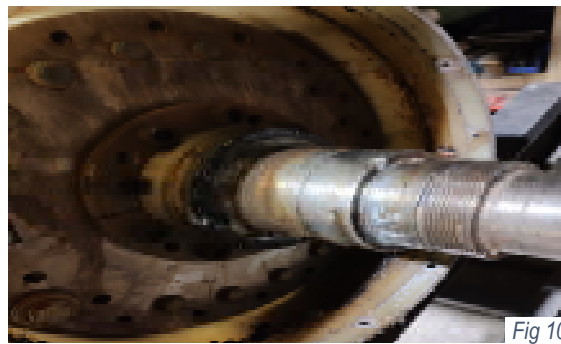
Fig 10

Removal of the Drive side high and slow speed bearing housing assembly's exposes the liquified state of the blacken & contaminated grease which once by-passing under the rear inner rotary seal lip the grease has then been expelled into the fibreglass cover, similar to the Non-Drive side.

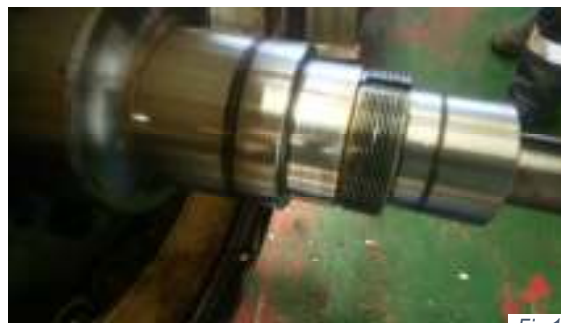
Fig 11

After thoroughly cleaning the bearing & seal journal diameters of the rotor shaft Drive end we found that the bearing journal was undersize from bearing movement and the seal journal diameter has worn below the recommended minimum standard from the effect of contaminated grease & debris passing under the sealing lip creating a grinding paste that has left an uneven & under size surface. Elevated temperatures have worsened the effect overtime.

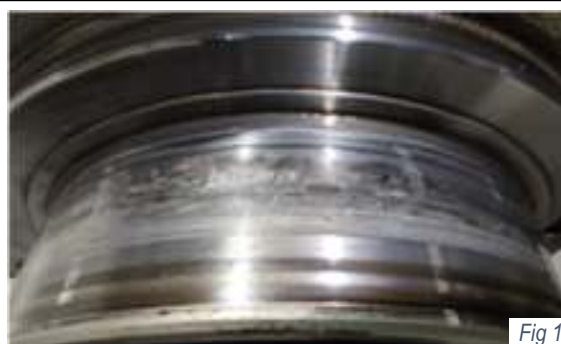
Fig 12

Drive highspeed bearing housing show signs that the slow speed bearing has been spinning on the spigot journal and grooved the bearing area below the acceptable level of contact.

The large seal journal preceding the spigot diameter is also deeply grooved from elevated temperatures and contaminated dried out grease being in contact with the running seal journal & acting as a cutting paste.

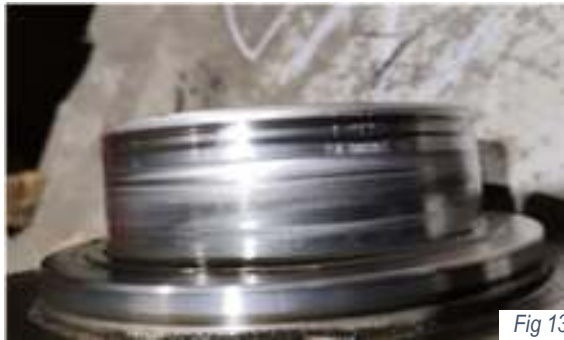
Fig 13

Non-Drive highspeed bearing housing show signs that the slow speed bearing has been spinning on the spigot journal and grooved the bearing area below the acceptable level of contact.

The large seal journal preceding the spigot diameter is also slightly grooved from elevated temperatures and contaminated from the effect of contaminated pressurized grease & debris passing under the sealing lip.

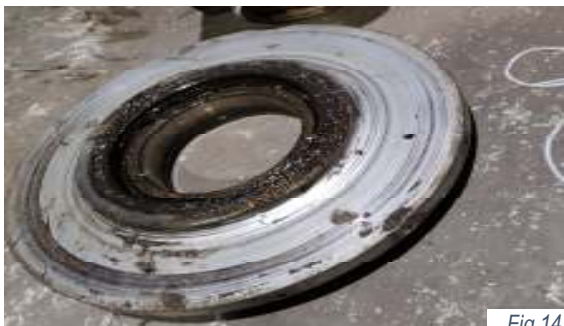
Fig 14

The Drive side slow speed bearing is heavily filled with blacken liquefied contaminated grease which has choked the rolling elements and would have further elevated running temperatures in operation.

The slow speed bearing shows clear signs of spinning in the bore which marries with the damage to the slow speed spigot journal damage in fig 12.

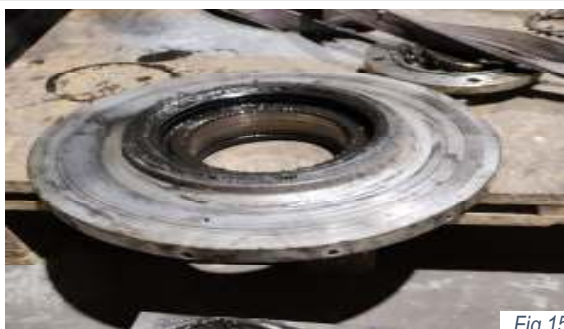
Fig 15

The Non-Drive side slow speed bearing is heavily filled with blacken liquefied contaminated grease which has choked the rolling elements and would have further elevated running temperatures in operation.

The slow speed bearing shows clear signs of spinning in the bore which marries with the damage to the slow speed spigot journal damage in fig 13.

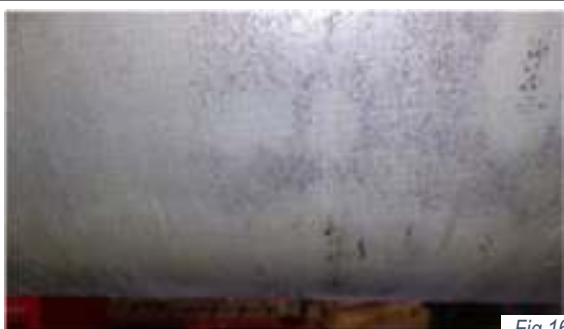
Fig 16

The Rotor fiber glass cover was thoroughly examined internal & external. Internally, grease has discolored the fiberglass cover at both ends and etched itself into the fiberglass fibers. A further inspection of the internal structure found the cover intact without holes. On the external cover surface, we noticed signs of wear, ferrous impregnation in the outer surface & minimum impact damage. Therefore, the fiberglass cover will require attention to make it acceptable for reuse.

1. Remove embedded grease from both internal ends, remove impregnated ferrous fractions from Fibre Glass Cover outside surface, polish and clean ready for reuse.
2. Replace all Highspeed & Slow speed bearing housings & flanges with New
3. Remove and Replace Rotor Drive shaft with New
4. Replace rotor shaft Clamping elements both ends
5. Replace all Highspeed & Slow speed bearings
6. Replace all Housing internal rotary seals
7. Rebalance rotor to G6.3 Grade
8. Fully rebuild ECS magnetic rotor
9. Manually rotate and inspect
10. Ensure equipment is inspected as per MHP EngServ/IFE guidelines. EIOP-2022

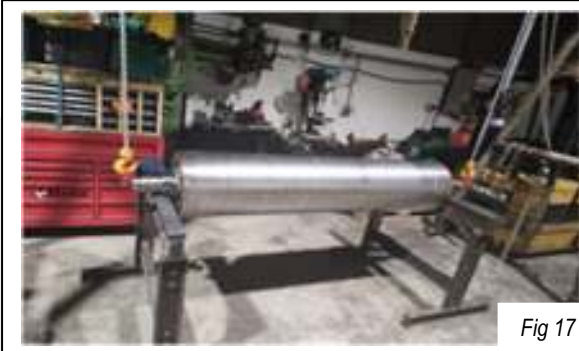
Examination of the core magnet system found the assembly intact, with no signs of damage to the magnet surface or separation of the core shells which would expose the inner magnet core.

The magnet was gauss tested and found to be at an acceptable level for continuous service.
